1198010003 - Madison County

Estate of Chemetco

**FOS File**

On September 23, 2010, Tom Miller and I conducted an inspection at Chemetco, Inc. Present during this inspection were Jorge Garcia, ES&H Manager for the Estate of Chemetco and David Herrera of AIS.

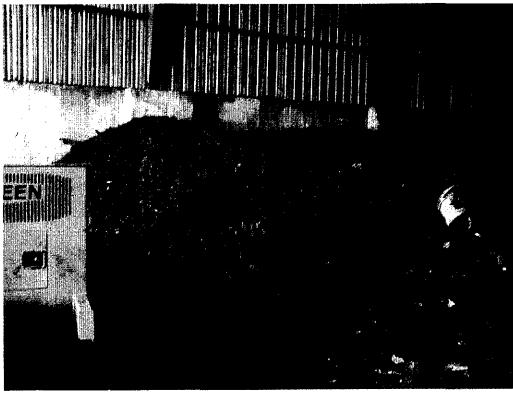
Date: 9/23/2010
Time: 10:15 - 11:00
Direction: Northwest
Photo by: Chris
Cahnovsky
Exposure #: 002
Comments: Concrete,
fines and waste
mixture

The concrete and fines mixture has been moved from the Tank House to the Fines Building. The amount moved was considerably more than two to three truck loads. It appears that about 20 truckloads of fines mixed with concrete and waste have been moved to the Fines Building. The waste in this building consists of plastic, pipes, metal valves, wood, metal pipe, and cinder blocks. A screener is in the building that will screen out anything over 1.5 inches. This screener was rented from a rock crushing company in Mascoutah, Illinois. Mr. Herrera stated that it should take AIS three days to screen this material. Mr. Herrera stated that he intend to move the screened debris back to the Tank House. This was not consistent with what AIS and IEPA had agreed to earlier in the week. It was the understanding of the IEPA that the screened material was going to be placed in a container for offsite shipment. He stated that a truck could not be staged next to the Fines Building. I stated that there was room to put roll-off boxes. I stated that AIS must not create new regulated units. I also expressed this to Mr. Garcia. It was later agreed that Mr. Herrera can store the screened material in the Fines Building until they are loaded onto a dump trailer for direct shipment to the disposal facility.

This email is to confirm the agreement that was reached at the site today with respect to the concrete rubble and trash mixed with the MDM from the Tank House that is currently in the Fines Building. AlS has a screen on site that will remove any debris that is over 1.5-2 inches. This material will be placed directly into roll-off boxes for waste profiling and disposal. No new regulated units will be created by moving this waste to other locations in the plant. It is the IEPA's understanding that the screening of this material will take about three days.

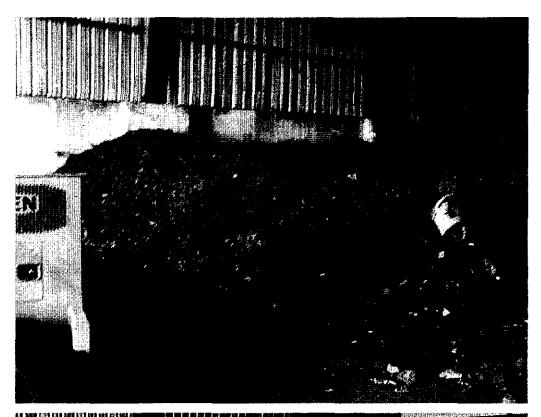
Date: 9/23/2010
Time: 10:15 - 11:00
Direction: Northwest
Photo by: Chris
Cahnovsky
Exposure #: 003
Comments: Concrete,
fines and waste
mixture

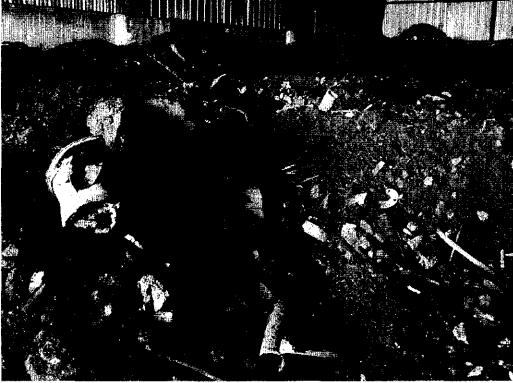
Date: 9/23/2010
Time: 10:15 - 11:00
Direction: West
Photo by: Chris
Cahnovsky
Exposure #: 004
Comments: Concrete,
fines and waste

mixture

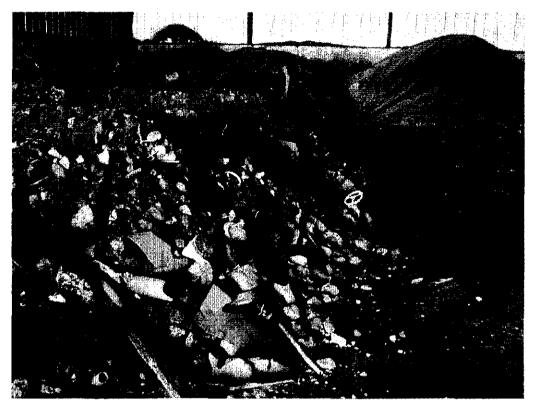
Date: 9/23/2010
Time: 10:15 - 11:00
Direction: Northwest
Photo by: Chris
Cahnovsky
Exposure #: 005
Comments: Concrete,
fines and waste
mixture

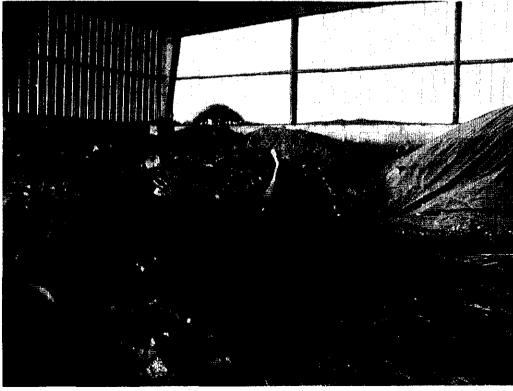
Date: 9/23/2010
Time: 10:15 - 11:00
Direction: Northwest
Photo by: Chris
Cahnovsky
Exposure #: 006
Comments: Concrete,
fines and waste
mixture

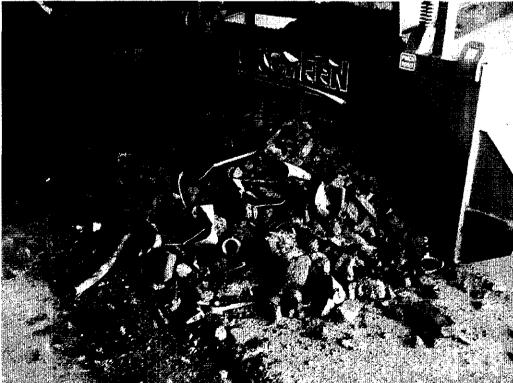
Date: 9/23/2010 Time: 10:15 - 11:00 **Direction: Northeast Photo by: Chris**

Cahnovsky Exposure #: 008 **Comments: Screen**

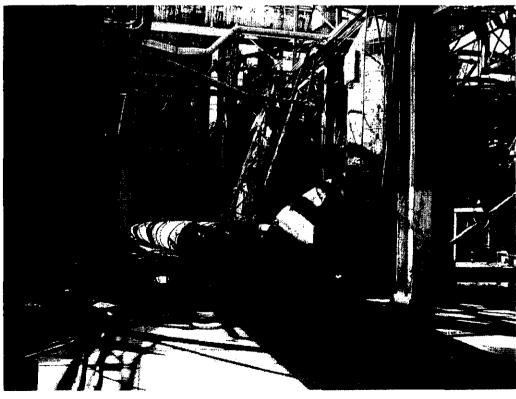
Date: 9/23/2010 Time: 10:15 - 11:00 Direction: North Photo by: Chris Cahnovsky Exposure #: 010 Comments: Stack

The last stack has been pulled down by the Estate. The AAF sump has been cleaned out. The sludge has been moved to the Fines Building and the water pumped to the North Cooling Canal. The sump pit was about six feet deep. The sump appeared to be in good condition with no cracks. There appeared to be a sealant on the concrete. I stated to Mr. Garcia that he should have a Professional Engineer look at this sump area while it is still clean.

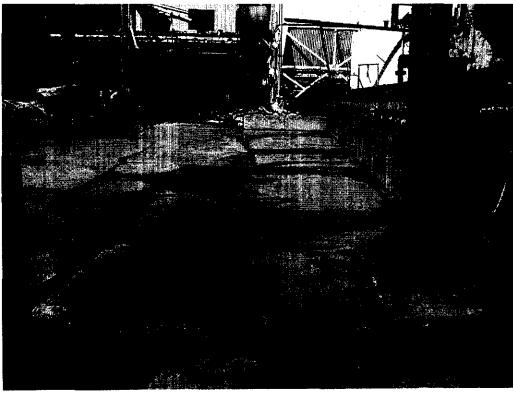
Date: 9/23/2010 Time: 10:15 - 11:00 Direction: West Photo by: Chris Cahnovsky Exposure #: 014 Comments: Former AAF decon area
